DYNAMIC SCIENCE, INC.
In-Depth Accident Investigation

Case DSI-94-SB-08

TECHNICAL SUMMARY

DYNAMIC SCIENCE, INC.
ACCIDENT INVESTIGATION
CASE NUMBER: DSI-94-SB-08

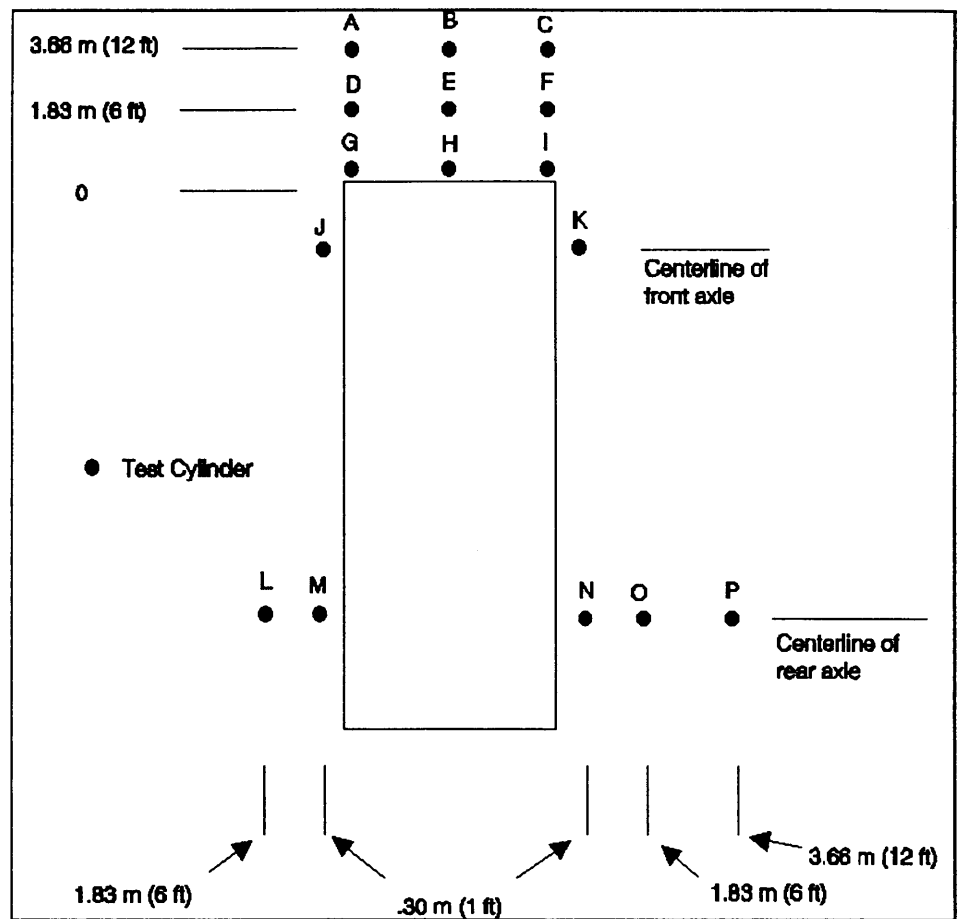
Figure 1. Location of Test Cylinders for School Bus Field-of-View Test

The school bus field-of-view test was conducted using orange test cylinders measuring 0.3048 m (1 ft.) high and 0.3048 m (1 ft.) in diameter. The test cylinders were positioned as depicted in Figure 1. All exterior mirrors had been repositioned prior to inspection (the bus had been repainted), but the test was conducted nonetheless.

The following table shows which test cylinders were visible using a given mirror as seen through the camera. The shaded areas represent test cylinders which were not visible using any of the mirrors.

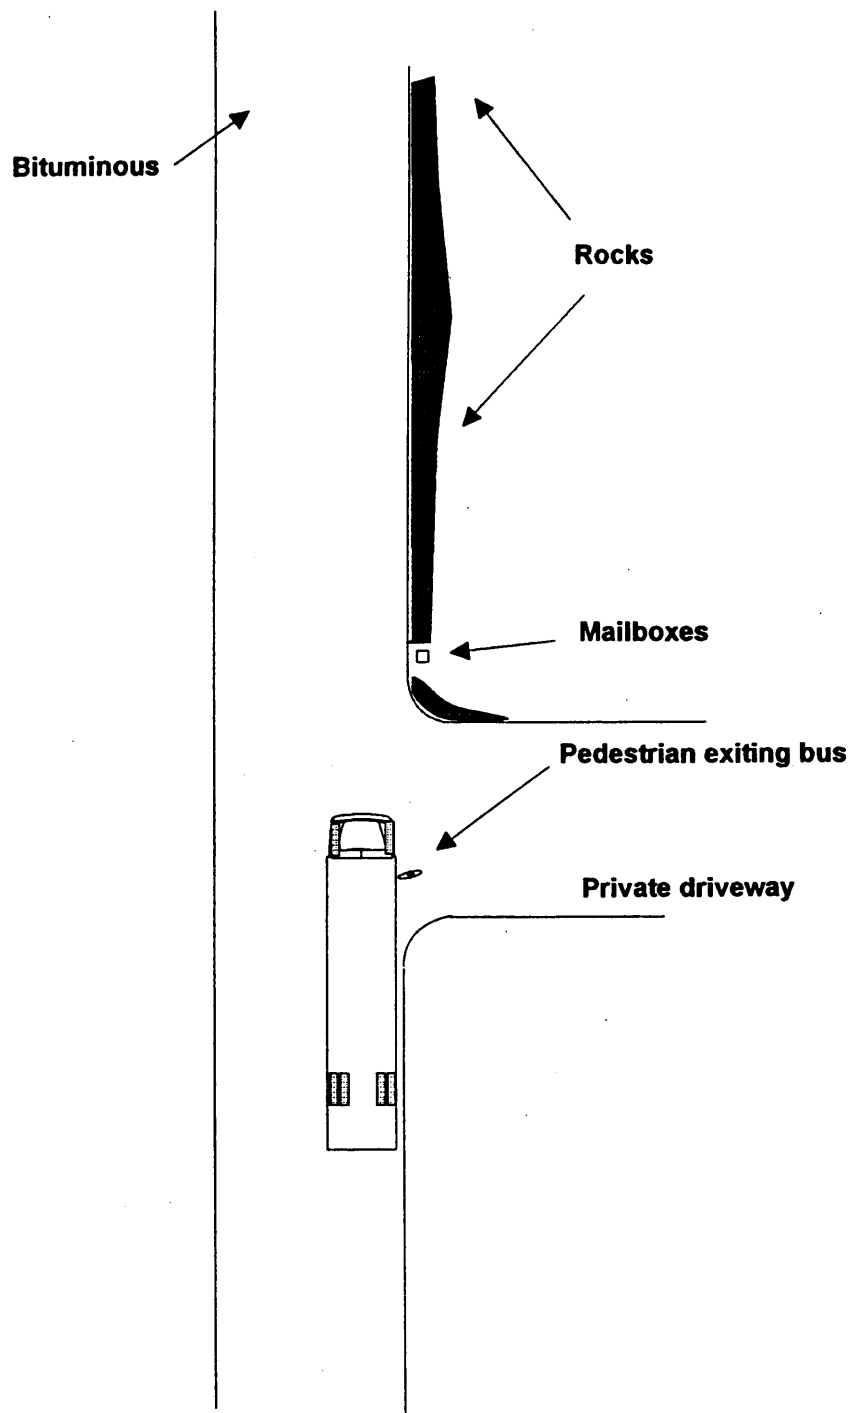
ACCIDENT SCHEMATIC

As the case subject was in the stepwell while departing the school bus, the right waist strap swung in a pendulum motion and travelled between the grab rail and the bulkhead, above the mounting bracket. The buckle was unable to pass through this opening. Due to the length of the strap she was able to exit the bus without any resistance. The bus driver closed the door and the bus began its forward motion. The case subject was pulled off her feet into the side of the bus. The strap broke and the case subject went to the ground and was run over by the right rear tires.

The 12 year old case subject was wearing a blouse and a skirt, and had both her arms through the arm straps of the backpack she was wearing. The waist straps were not fastened. The right side strap slipped into the gap between the floorboard and the grab rail mounting bracket. The door of the bus closed and it began its forward motion. The case subject would have been pulled off her feet in a clockwise direction with her head facing east. There was evidence along the side of the bus that the case subject was initially pulled into the side of the bus before the the strap broke and she fell to the ground where she was run over by the right rear dual tires.

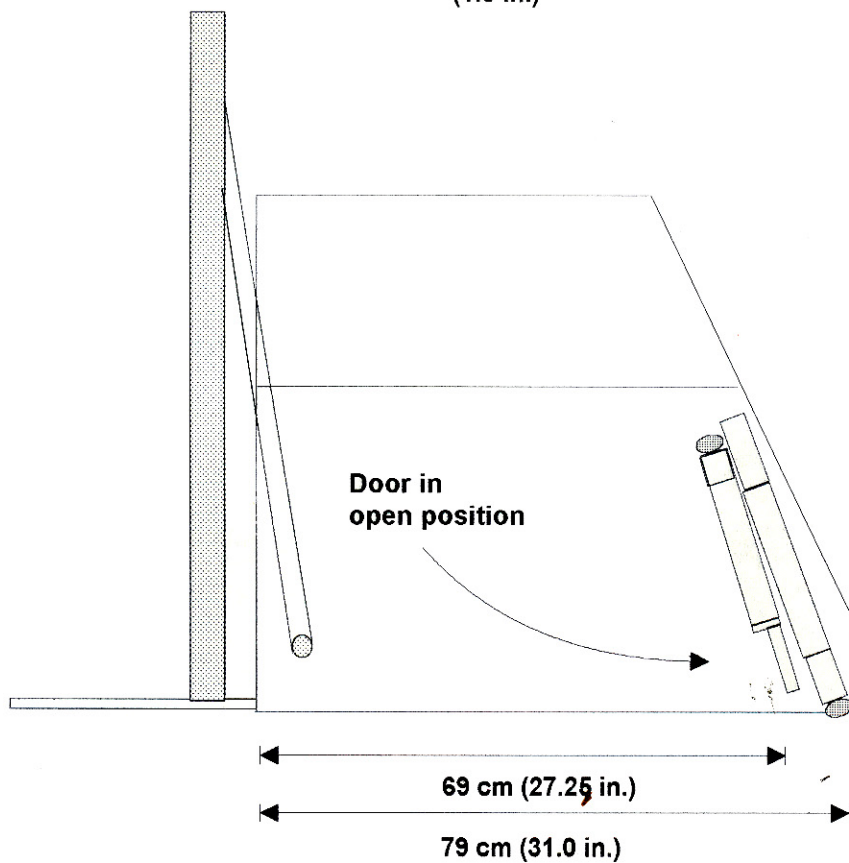
Handrail/Stepwell

The school bus has a three step entrance/exit to and including the floor of the bus. There is a passenger grab rail on the right side of the step well as one exits the coach. The grab rail is constructed of 2.5 cm (1 in.) tubular stainless steel. The grab rail is positioned at a 45 degree angle downward from the top of the stairwell for approximately 52 cm (20.5 in.), with approximately an 8 cm (3.0 in.) clearance from the upper seatback, then a 90 degree angle downward for 31 cm (12.25 in.) to the passenger floorboard, where a mounting bracket is located. The grab rail is approximately 17 cm (6.5 in.) long from the mounting bracket to the end of the rail, where it is secured to the stairwell. The grab rail's distance narrows between it and its mounting as it approaches the door exit. Upon reaching the mounting bracket located 61 cm (24.0 in.) up from the bottom step there is a distance of approximately 3 cm (1.0 in.) between the handrail and the passenger flooring. The side door measures 81 cm (32.0 in.) by 198 cm (78 in.).

I ENTERED THE SCHOOL BUS TO SPEAK TO THE STUDENTS WHO WERE STILL SEATED ON THE BUS. WHEN I STARTED UP THE STAIRWELL I OBSERVED A BLACK STRAP HANGING FROM THE HANDRAIL NEAR ITS BASE AT THE POINT OF EXIT, MEASURING APPROXIMATELY 3' 01" HEIGHT FROM GROUND.
